**TANKS ILLUSTRATED NO. 9**

# Last of the **Panzers**

**German Tanks 1944-45**

**WILLIAM AUERBACH**

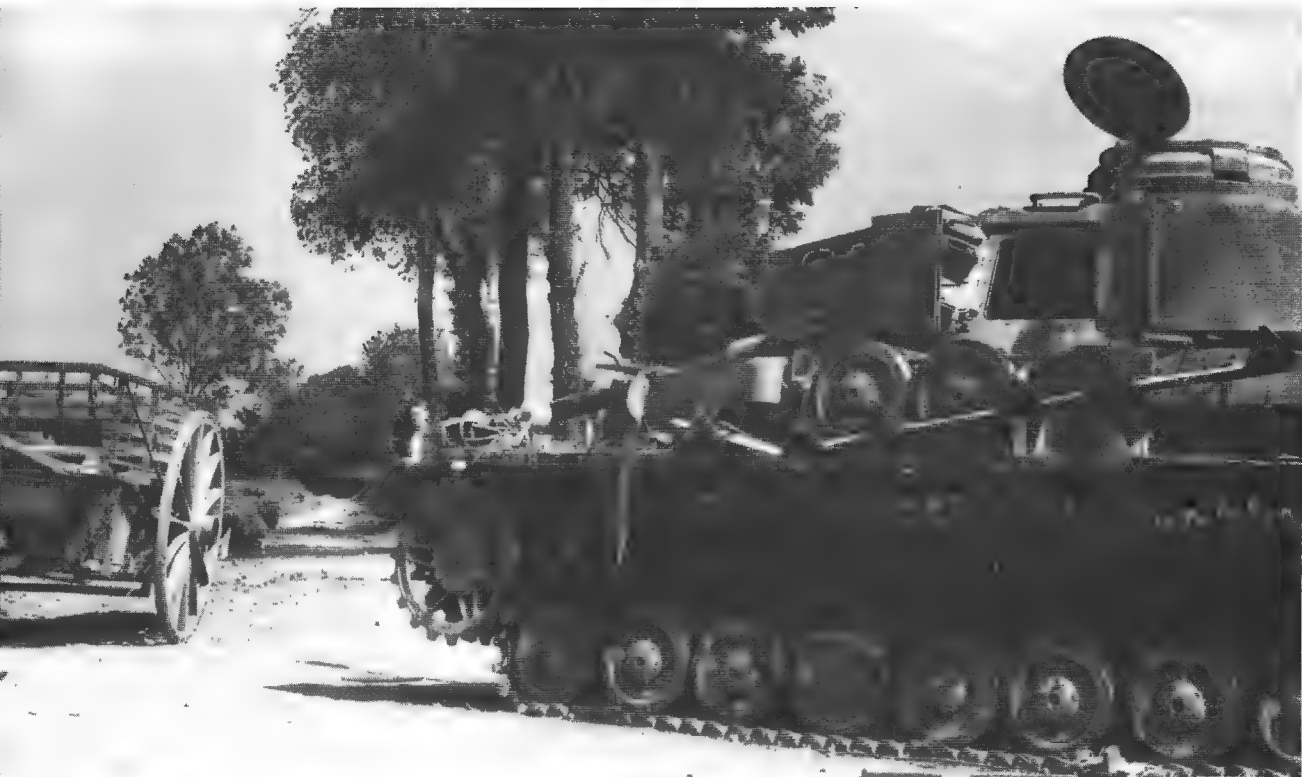
40▲ 41▼

40. Local farmworkers study a Pz Kpfw IV Ausf H which has tried to make do with a damaged track, by looping the shortened track from the return roller directly to the first road wheel. Note the steel return rollers, the absence of a driver's side visor, and the vision device in the turret door. The turret schurzen was surprisingly rigid and usually stayed on long after the side plates were lost. Villy, France, 26 August 1944. (PA-130181/Public Archives of Canada)

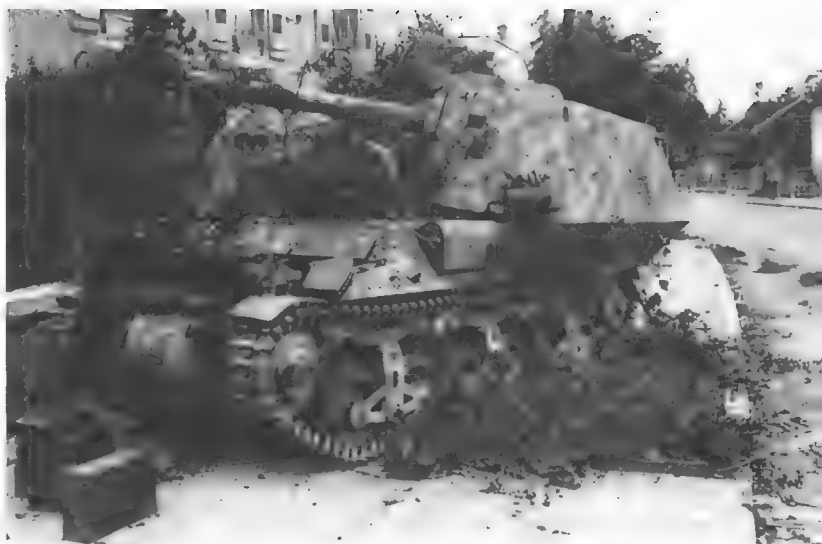
51▲

51. Front view of a 7.5cm PaK40 1 auf GW Lorraine Schlepper (f), no. 322, abandoned in Vesoul, France, 13 September 1944. Spare bogies are carried behind the travel lock, and the driver's open compartment is littered with a bazooka, rockets and 2cm ammunition. Note the handles and the 'tac' sign on the transmission housing and the bolted shield for the PaK40.

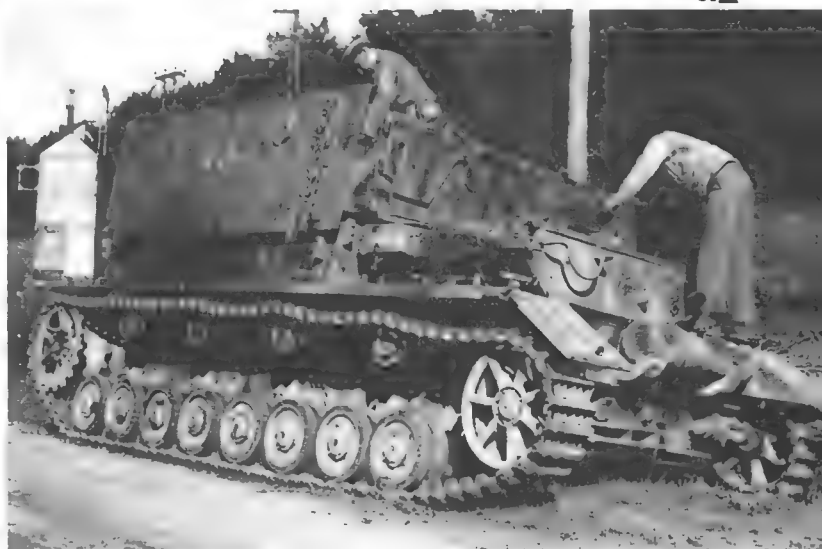
53. Another 3.7cm-equipped 'Möbelwagen', no. 011, based on the late Pz Kpfw IV Ausf J chassis, with vertical exhaust mufflers, four steel return rollers and late sprocket/early idler combination. The side shields, again, are completely flat, but lack the two support brackets in this instance. The hinged sections on the rear shield have been swung outwards.

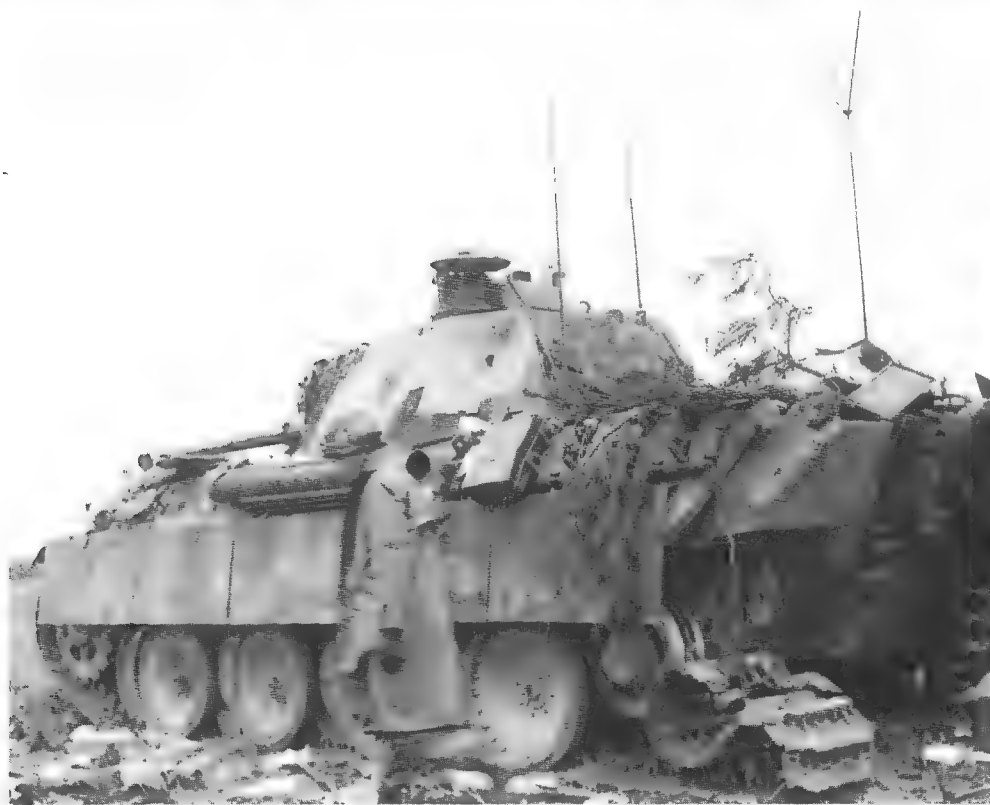
▲54 ▼55

54. Mid-production StuG III Ausf G, run aground near Luneville, France, 29 September 1944, sporting 30mm armour bolted to basic 50mm superstructure armour, steel return rollers, 'Saukopf', late-pattern muzzle brake, plated over opening for remote-controlled MG, 'Nahverteidigungswaffe', schurzen, lugs on roof for 2-ton crane, travel lock and zimmerit.

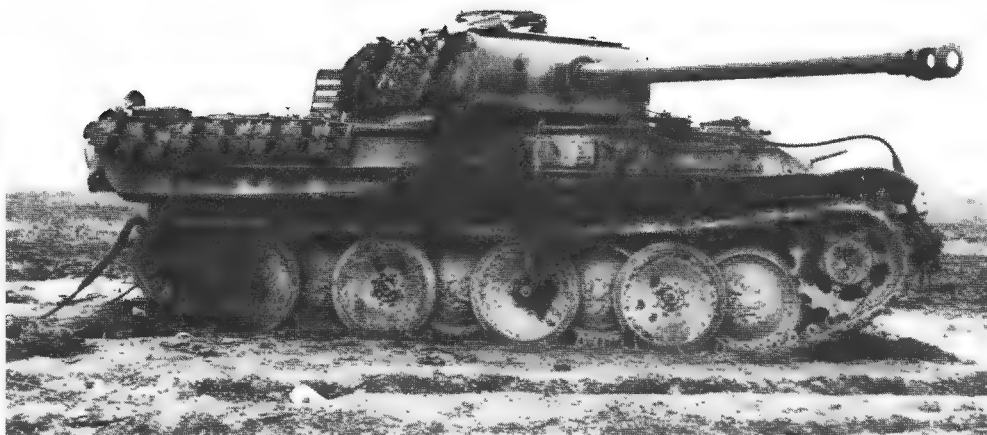
56▲

56. Side view of a Panther Ausf G showing its stark

outlines and 'chin' mantlet with rain guard. The side armour was increased on the upper hull side from 40mm to 50mm, and spare track was hung on the turret sides to increase protection. Note the total absence of zimmerit. (C-84047/Public Archives of Canada)

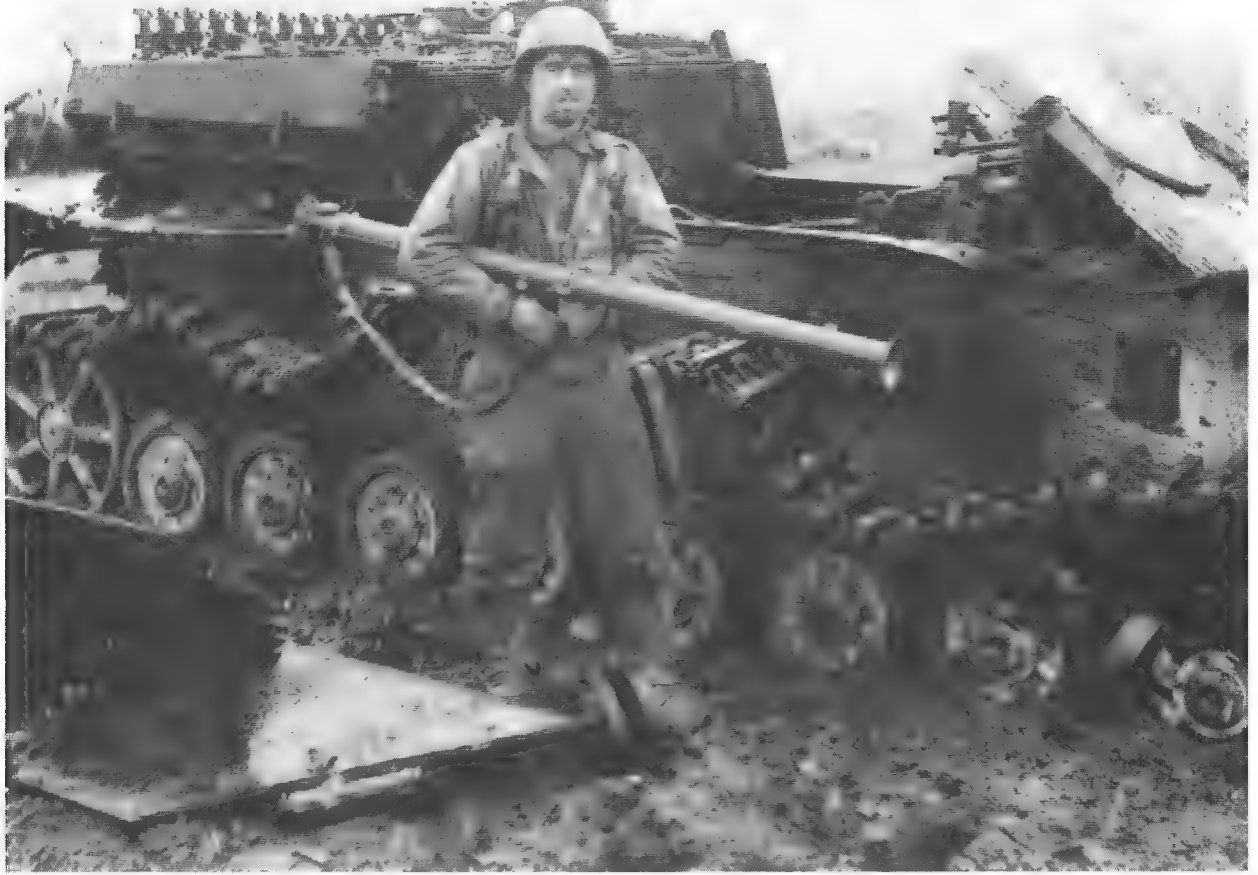
61▲

61. This American private of K Company, 16th Regiment, 1st Division, poses in front of a Panzer IV/70(V) which he destroyed with a bazooka during a German counterattack near Hamich, Germany, 22 November 1944. The 80mm frontal armour is very evident. Although the front bogies are rubber-tyred, the flange for the gun mantlet tapers to allow for the larger MG port cover on the L/70 version. (US Army Official Photograph)

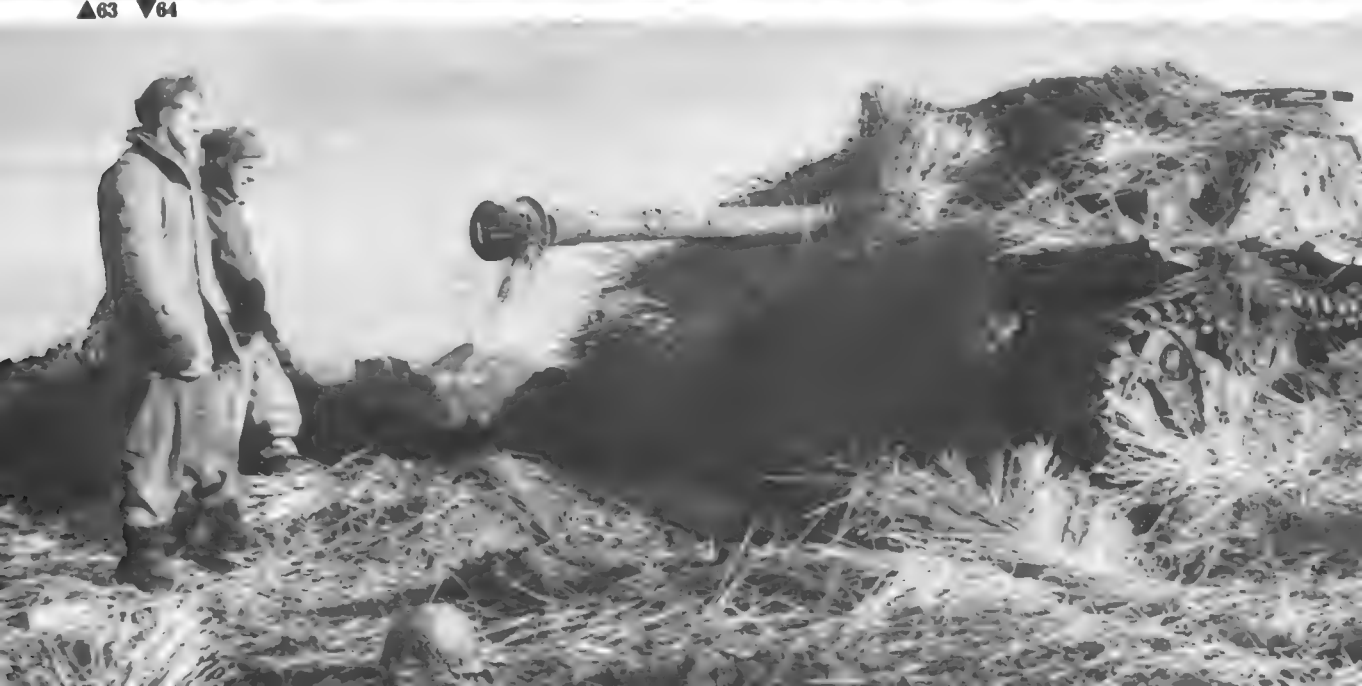
▲63 ▼64

64. Members of the 3rd Armored Division inspect a straw-covered StuG III Ausf G abandoned near Obergeich, Germany, 11 December 1944, no doubt relieved that they did not have to face its powerful cannon and compact hull across the broad fields. This StuG has steel return rollers, but does not appear to have ever been fitted with skirt armour.

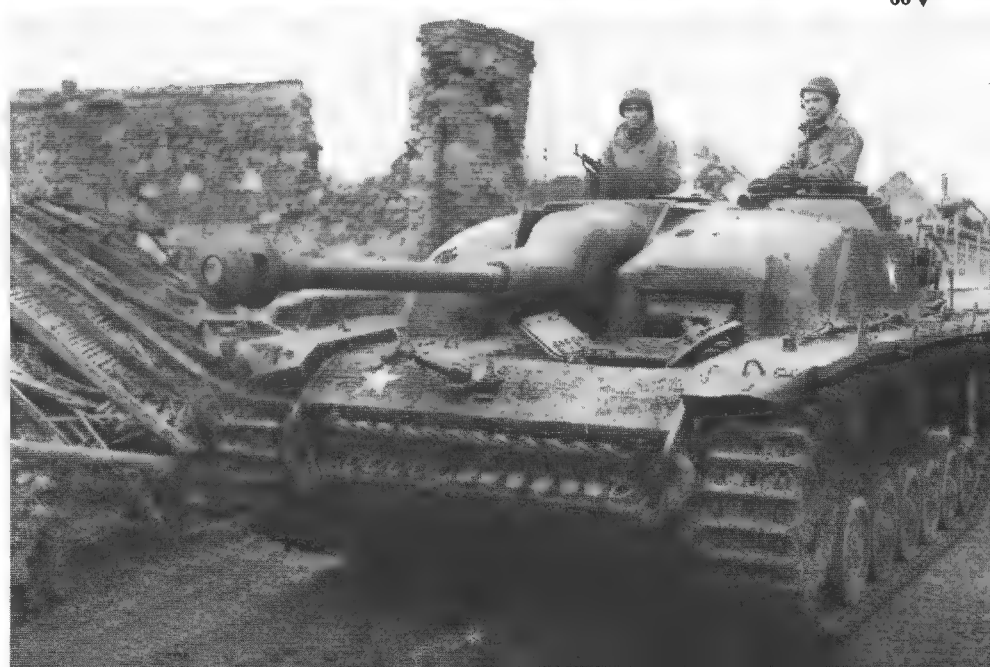
66 ▼

66. Members of an anti-tank platoon and their newly-acquired StuG III Ausf G roll down a street near Inden, Germany, 17 December 1944. This StuG carries a thick layer of concrete on the superstructure front and sides, 'Saufkopf', waffle-pattern zimmerit, steel return rollers, track chevrons, remote-controlled MG (shown here with an assault rifle in place of the MG) and late-pattern muzzle brake. Numerous wire loops have been spot welded to the hull front and trackguard to secure foliage.

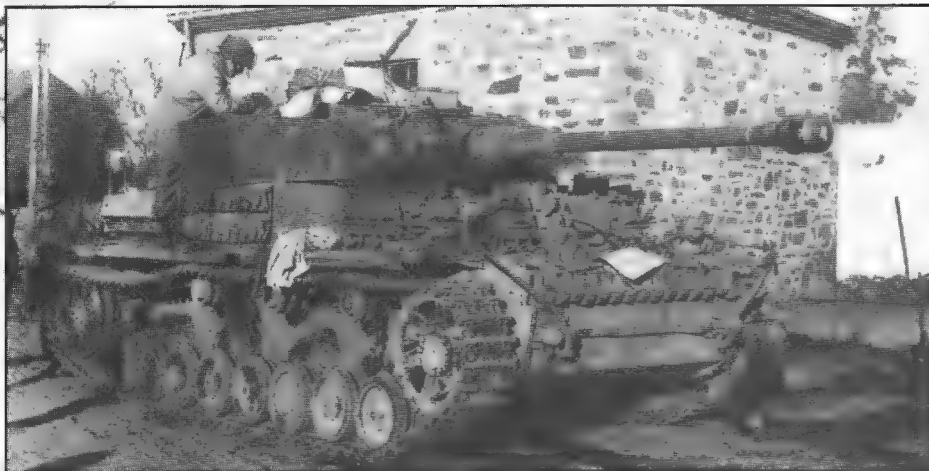
▲67  
67. A Pz Kpfw IV late Ausf H or early J, captured intact by men of the 101st Airborne Division when it attempted to storm Bastogne, 26 December 1944. This vehicle has the late sprocket/idler, four steel return rollers, interlocked 80mm hull front, schurzen and lots of spare track. Its L/48 cannon with 'H'-pattern muzzle brake has one kill ring and the name 'Lustmolch' painted on it. The vehicle took a hit to the top right front of the turret.

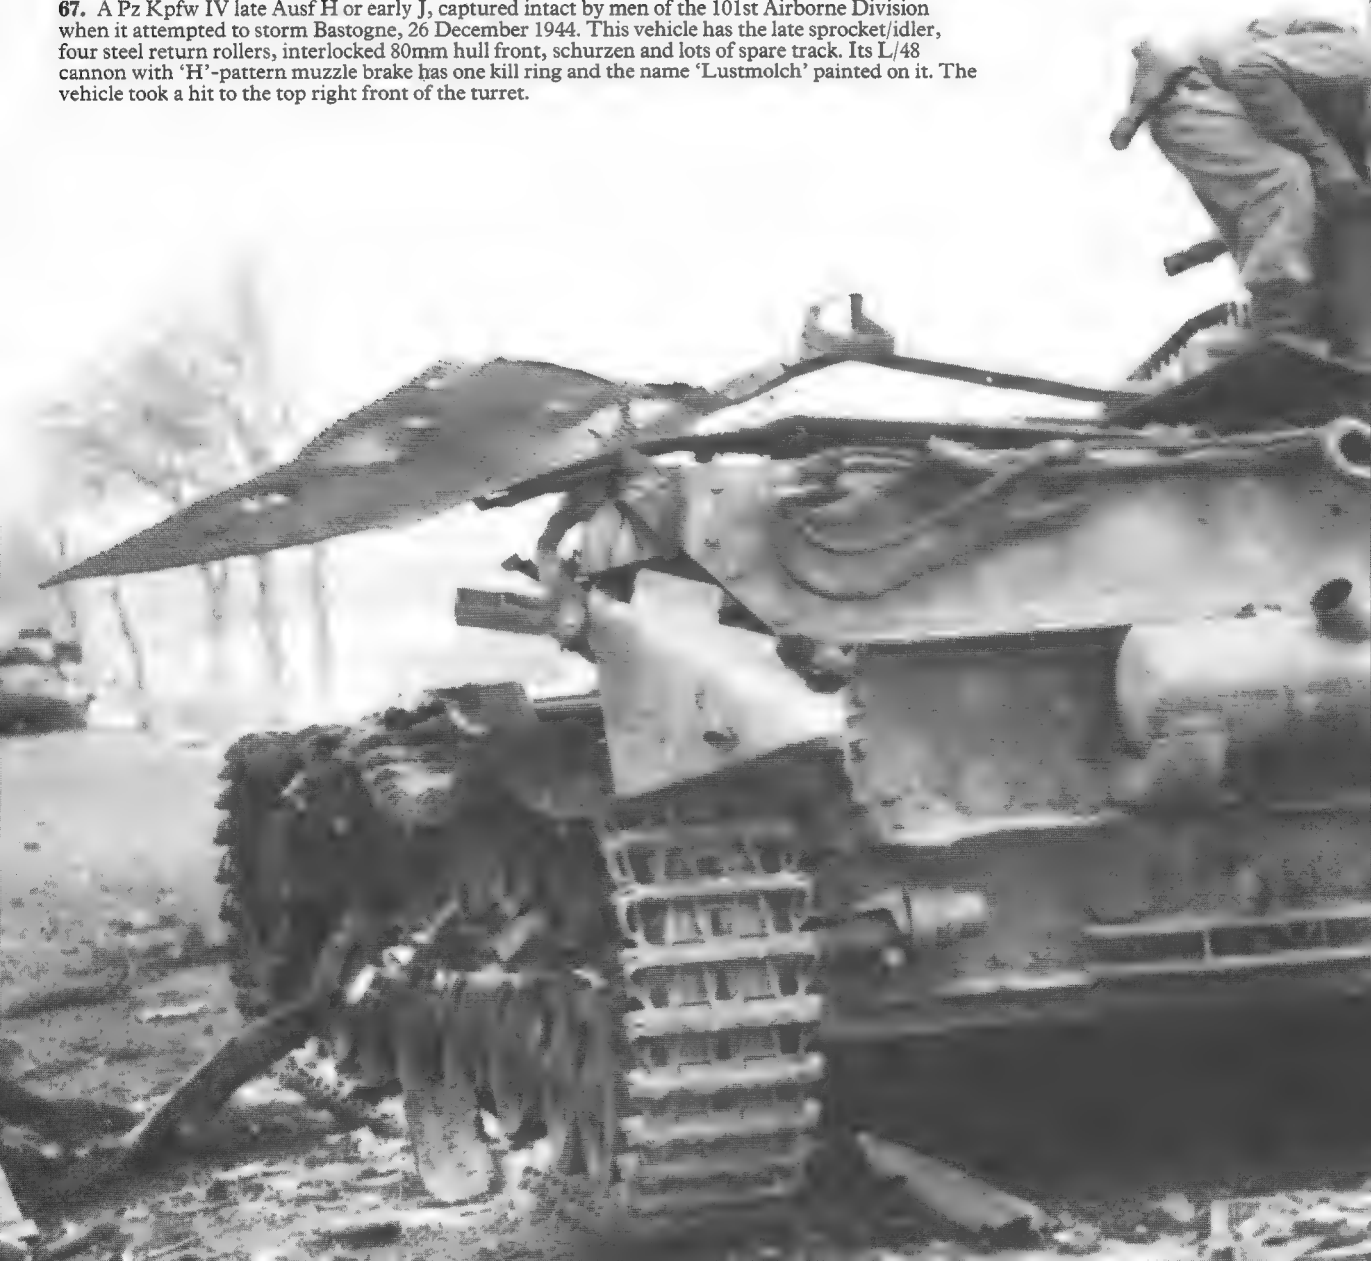
▼68

68. This Pz Kpfw IV Ausf J met its end at the hands of an American tank destroyer in Wirtzfeld, Belgium, 17 December 1944, when an anti-tank round smashed through the left side of the turret. The vehicle has the old muffler, late sprocket/idler, steel return rollers, wire mesh schurzen and track chevrons, but lacks zimmerit, vision ports in the turret hatches and super-structure sides and the vertical brackets on the lower rear hull.

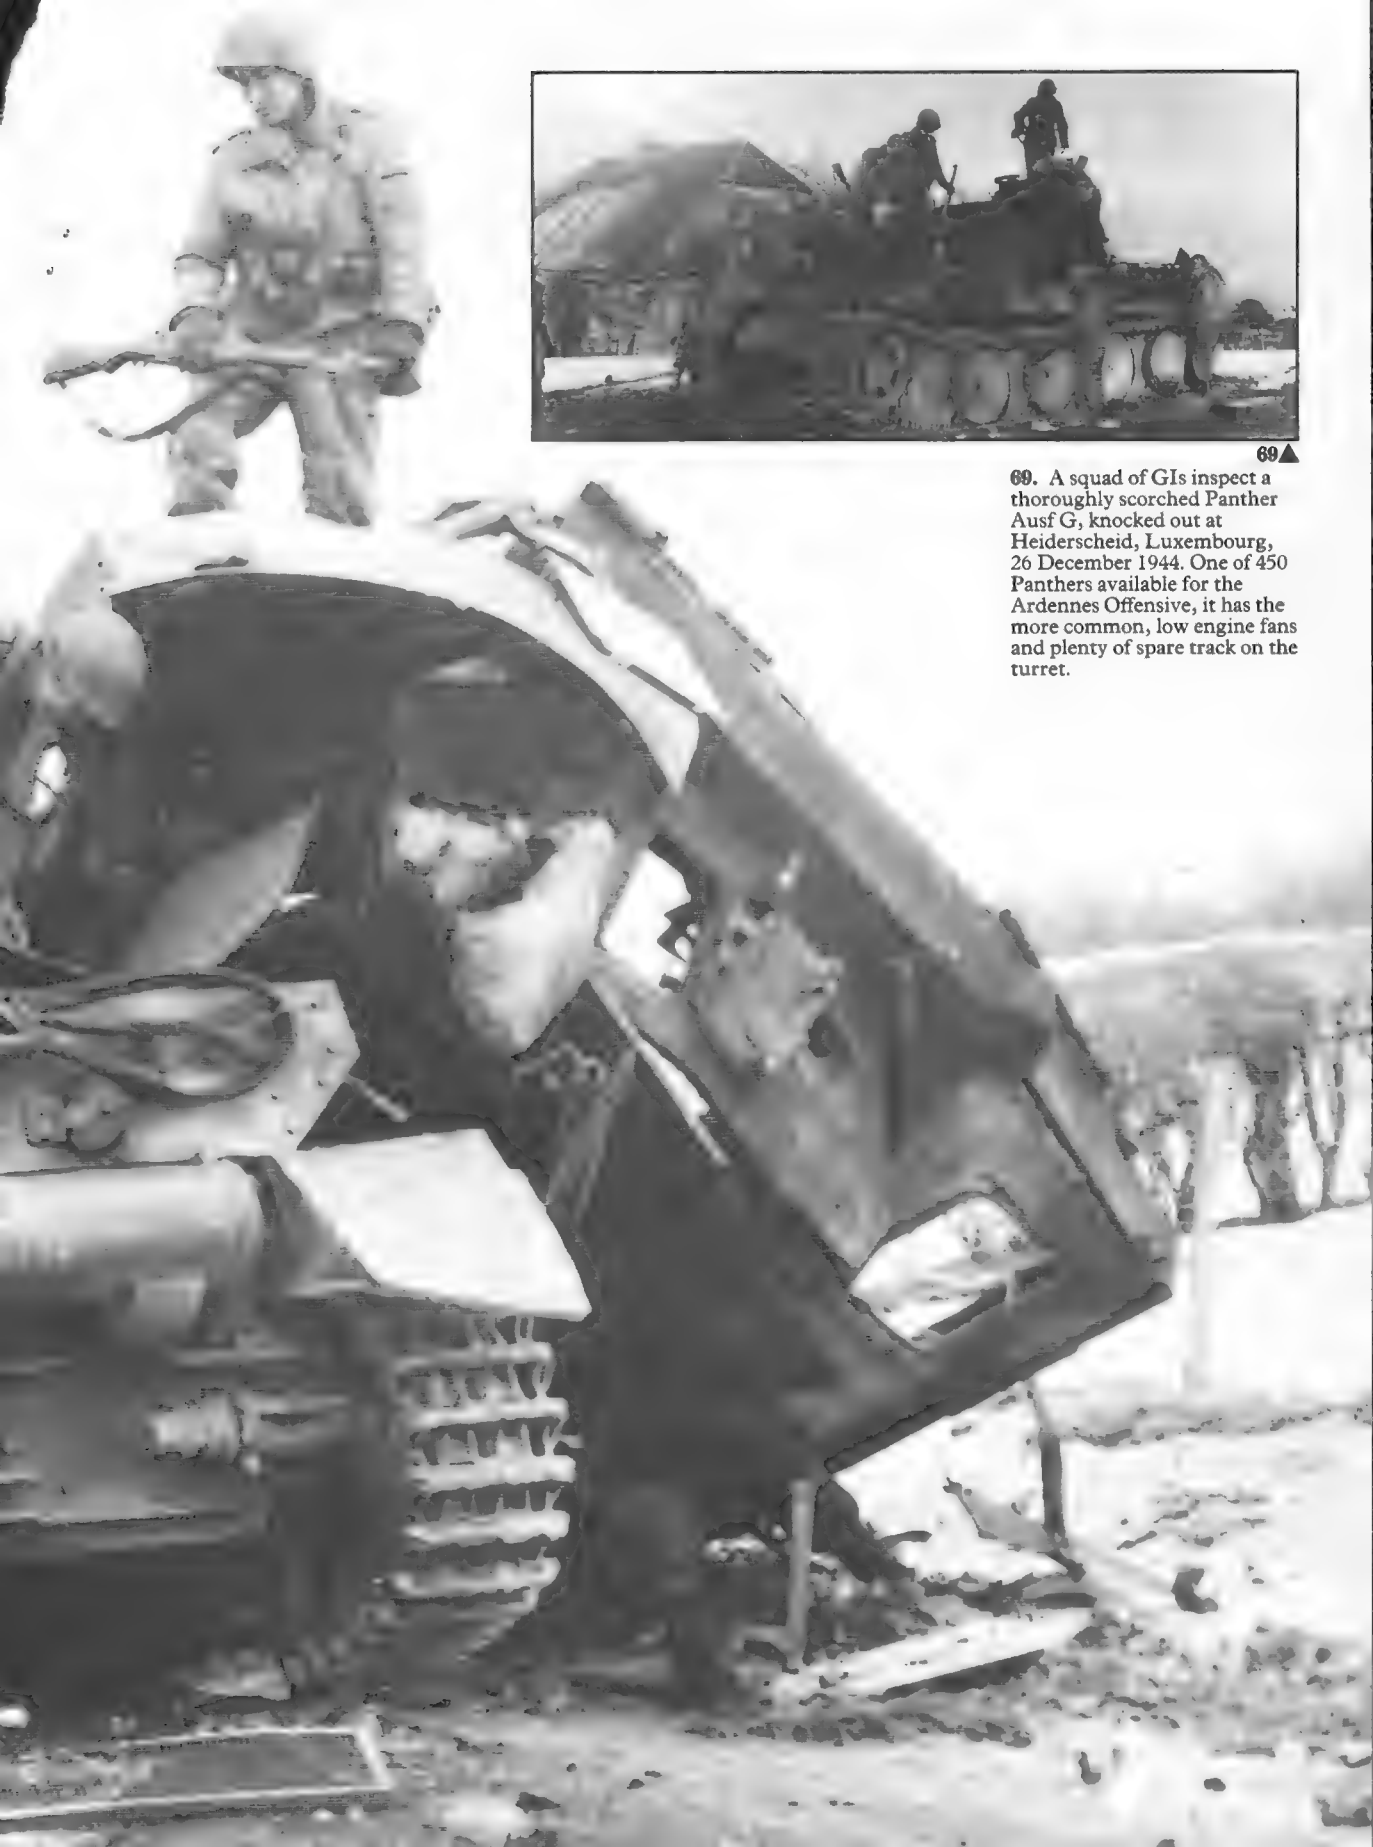
69▲

69. A squad of GIs inspect a thoroughly scorched Panther Ausf G, knocked out at Heiderscheid, Luxembourg, 26 December 1944. One of 450 Panthers available for the Ardennes Offensive, it has the more common, low engine fans and plenty of spare track on the turret.

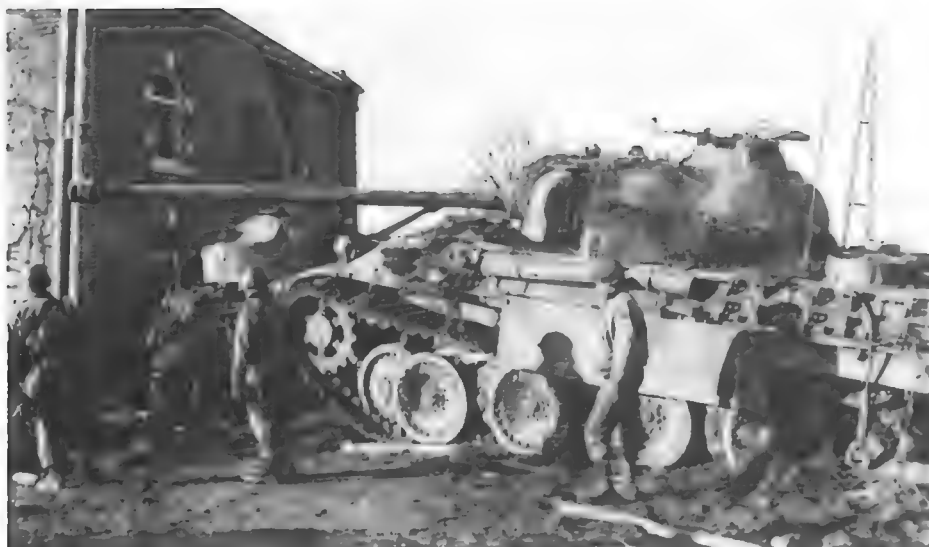
▲70

**70.** Two more vehicles from the German spearhead into the Ardennes, knocked out by the 3rd Armored Division during bitter fighting in Hotten, Belgium, 26 December 1944. The Panther Ausf G has the new mantlet, high engine fans and 'ambush' paint scheme. Behind it is a Pz Kpfw IV Ausf J.

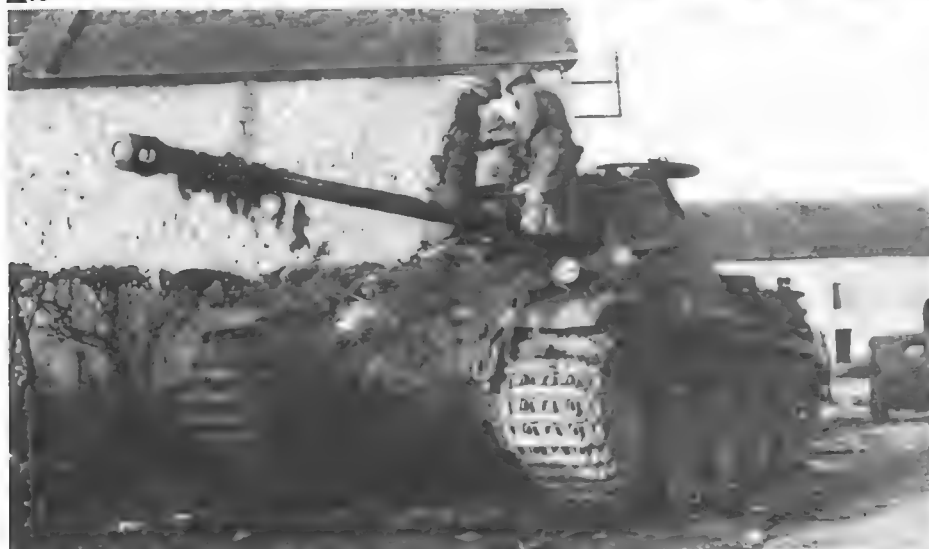
▲71 ▼72

**71.** American soldiers of the 329th Regiment, 83rd Division, calmly stringing communications cable across a Panther Ausf G, knocked out in the battle for Humain, Belgium, 28 December 1944. The vehicle took hits to the bow MG, right front corner of the turret and middle of the mantlet. It has the high engine fans and a small number '80' outlined on the turret side just before a similar-sized German cross.

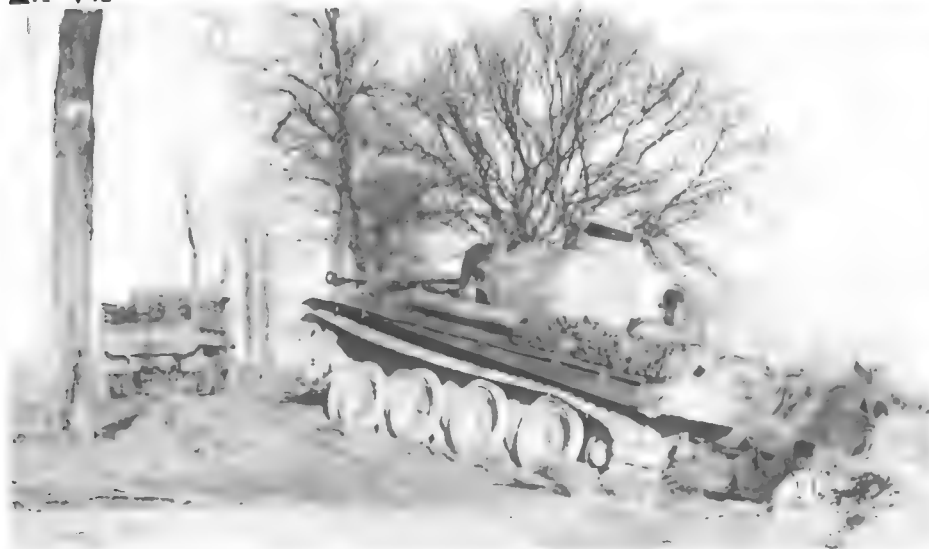
**72.** Panther Ausf G with high engine fans, 'chin' mantlet and soft-edge camouflage scheme, knocked out near Buissonville, Belgium, 29 December 1944. This Panther looks relatively new, and has shields around the exhaust pipes. It seems that the driver was slewing the vehicle sharply as the result of track damage when the turret front was fractured by anti-tank rounds.

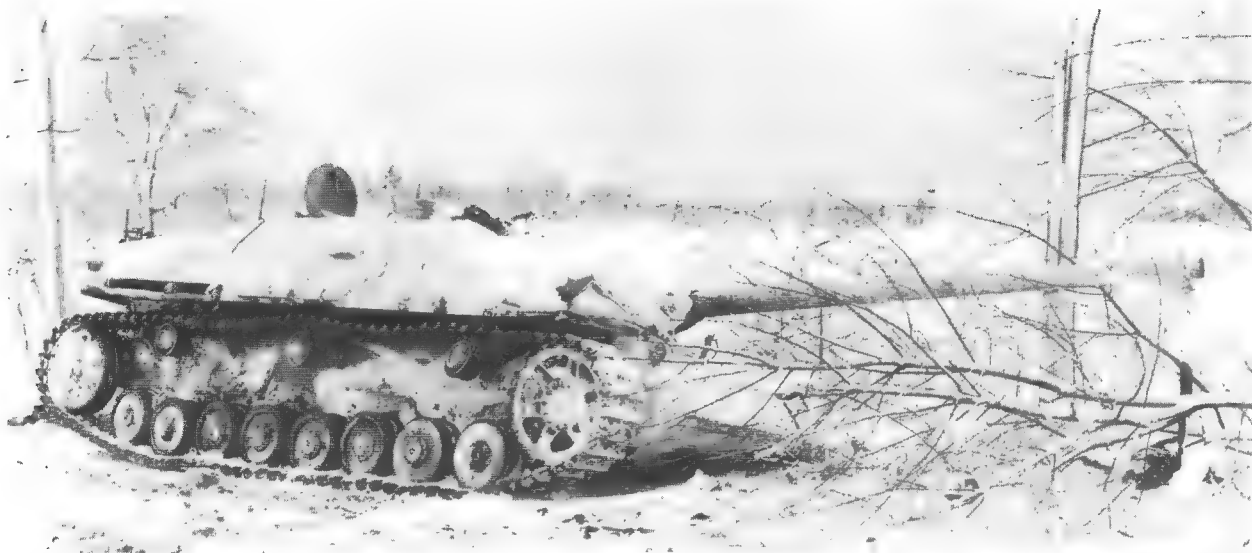
73▲ 74▼

**73.** Front 1/2 view of a late-production Panzer IV/70(V) produced during Oct-Nov 1944 and disabled during the Ardennes Offensive shortly afterwards. Note the excessive overhang of the barrel, three steel return rollers and steel-tired bogies in the first two positions.

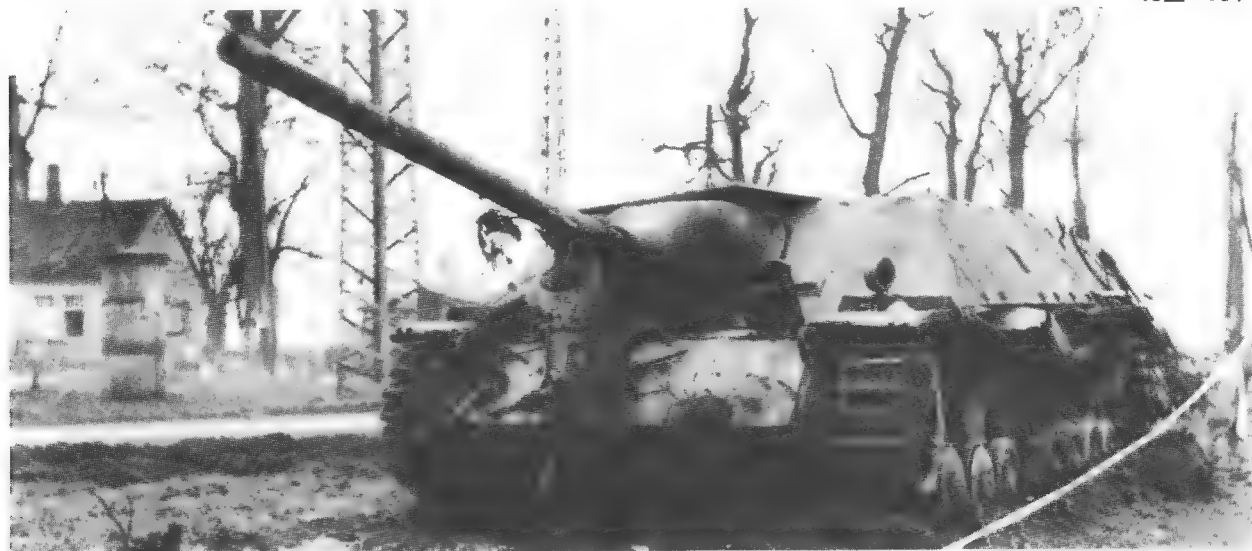
**74.** The compact lethality of this Panzer IV/70(V) shows to good effect in this photograph, taken in the Canadian sector. This model lacks zimmerit, and has only three steel return rollers, which places its production at some time after October 1944. (C-84045/Public Archives of Canada)

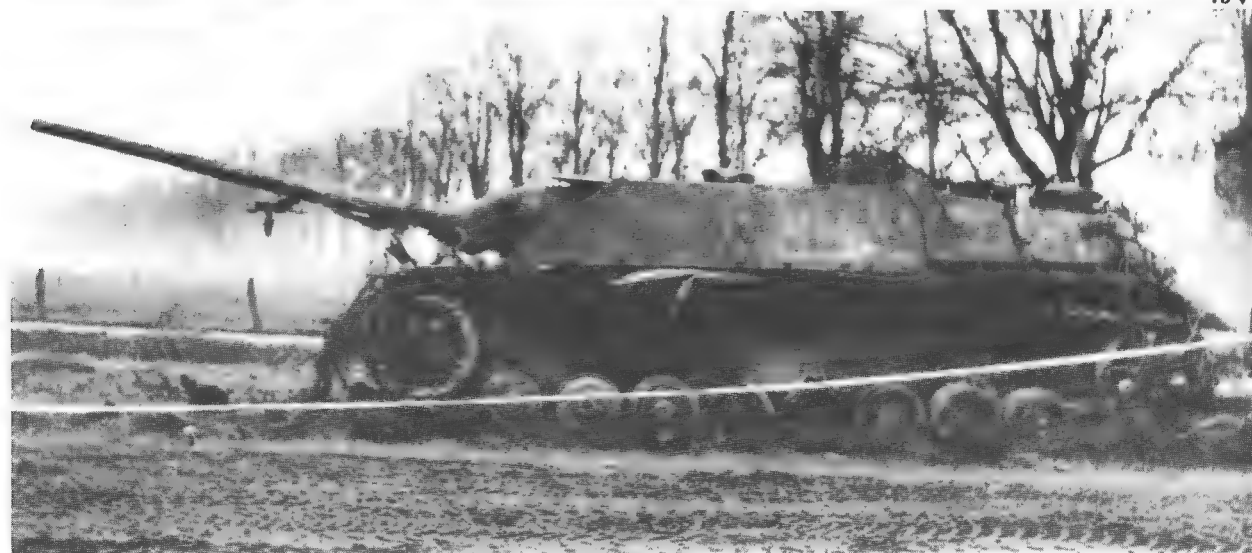
75▼

**75.** Side view of the same vehicle, which stood less than two metres high. As a remedy to its nose heaviness, caused by the longer gun and 80mm upper hull armour, the first two bogie wheels are of the steel resilient type. The usual schurzen has been pared away leaving only the attachment bolts along the superstructure sides. (C-84044/Public Archives of Canada)

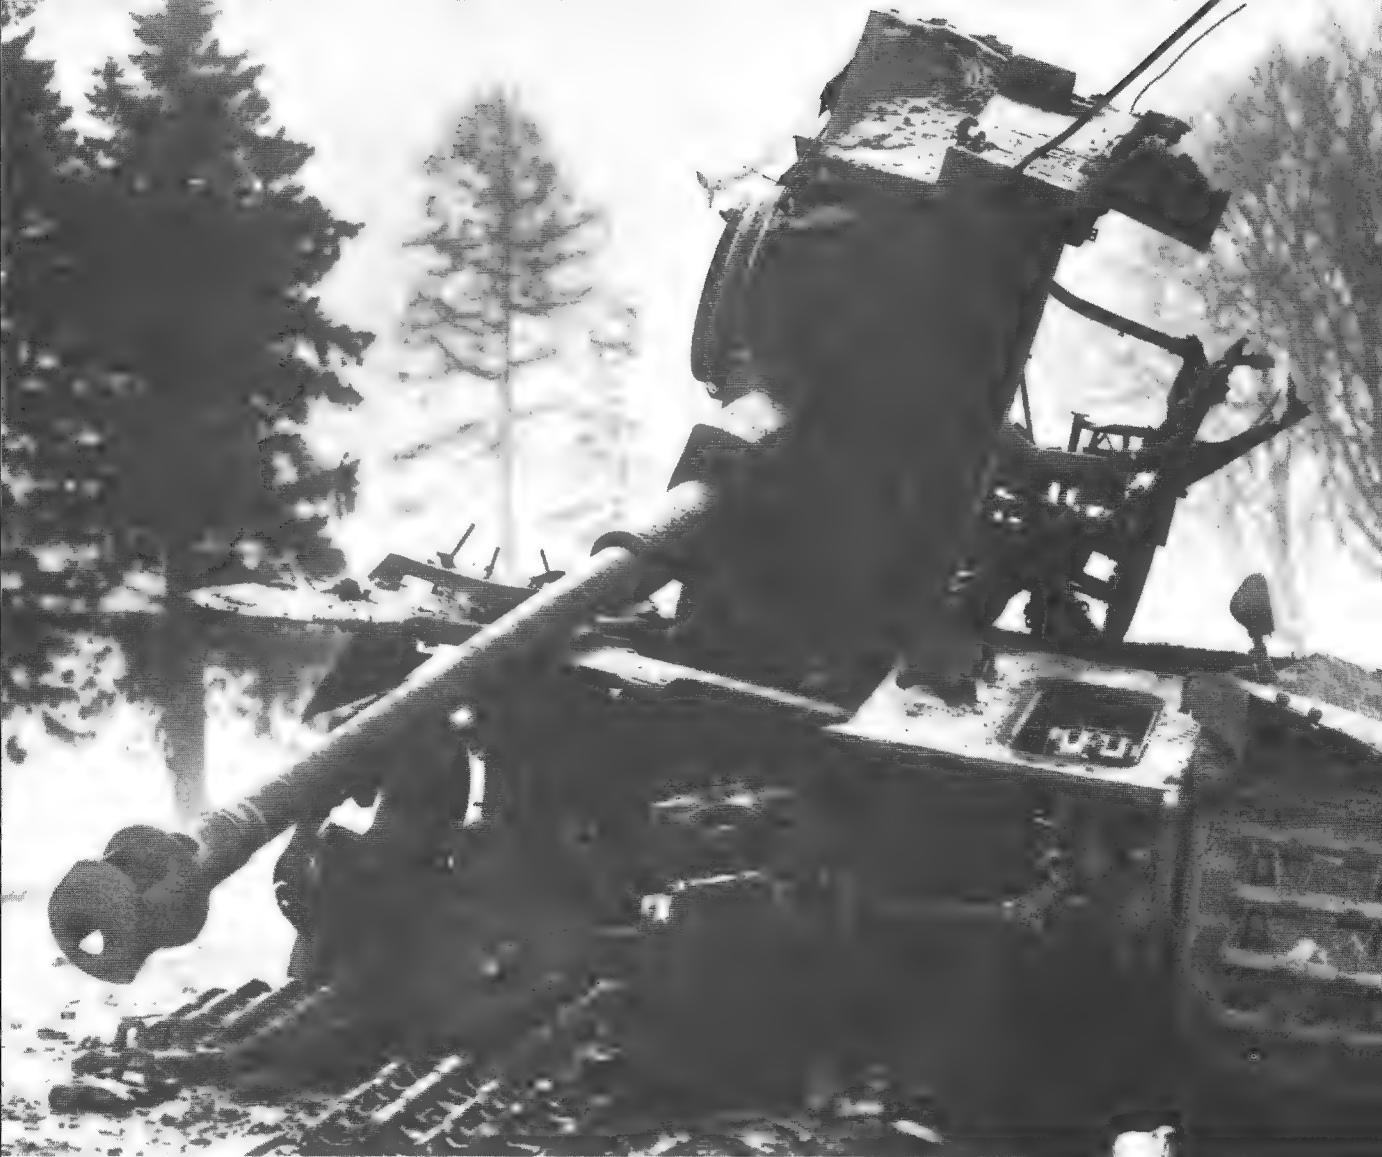
▲76 ▼77

**76.** A Pz Kpfw IV Ausf H, disembowelled by determined American resistance near Bastogne, 3 January 1945. This model featured basic 80mm frontal armour, the SSG77 transmission and deletion of side vision ports for the driver and radio operator. Note the muzzle brake and the neat application of zimmerit.

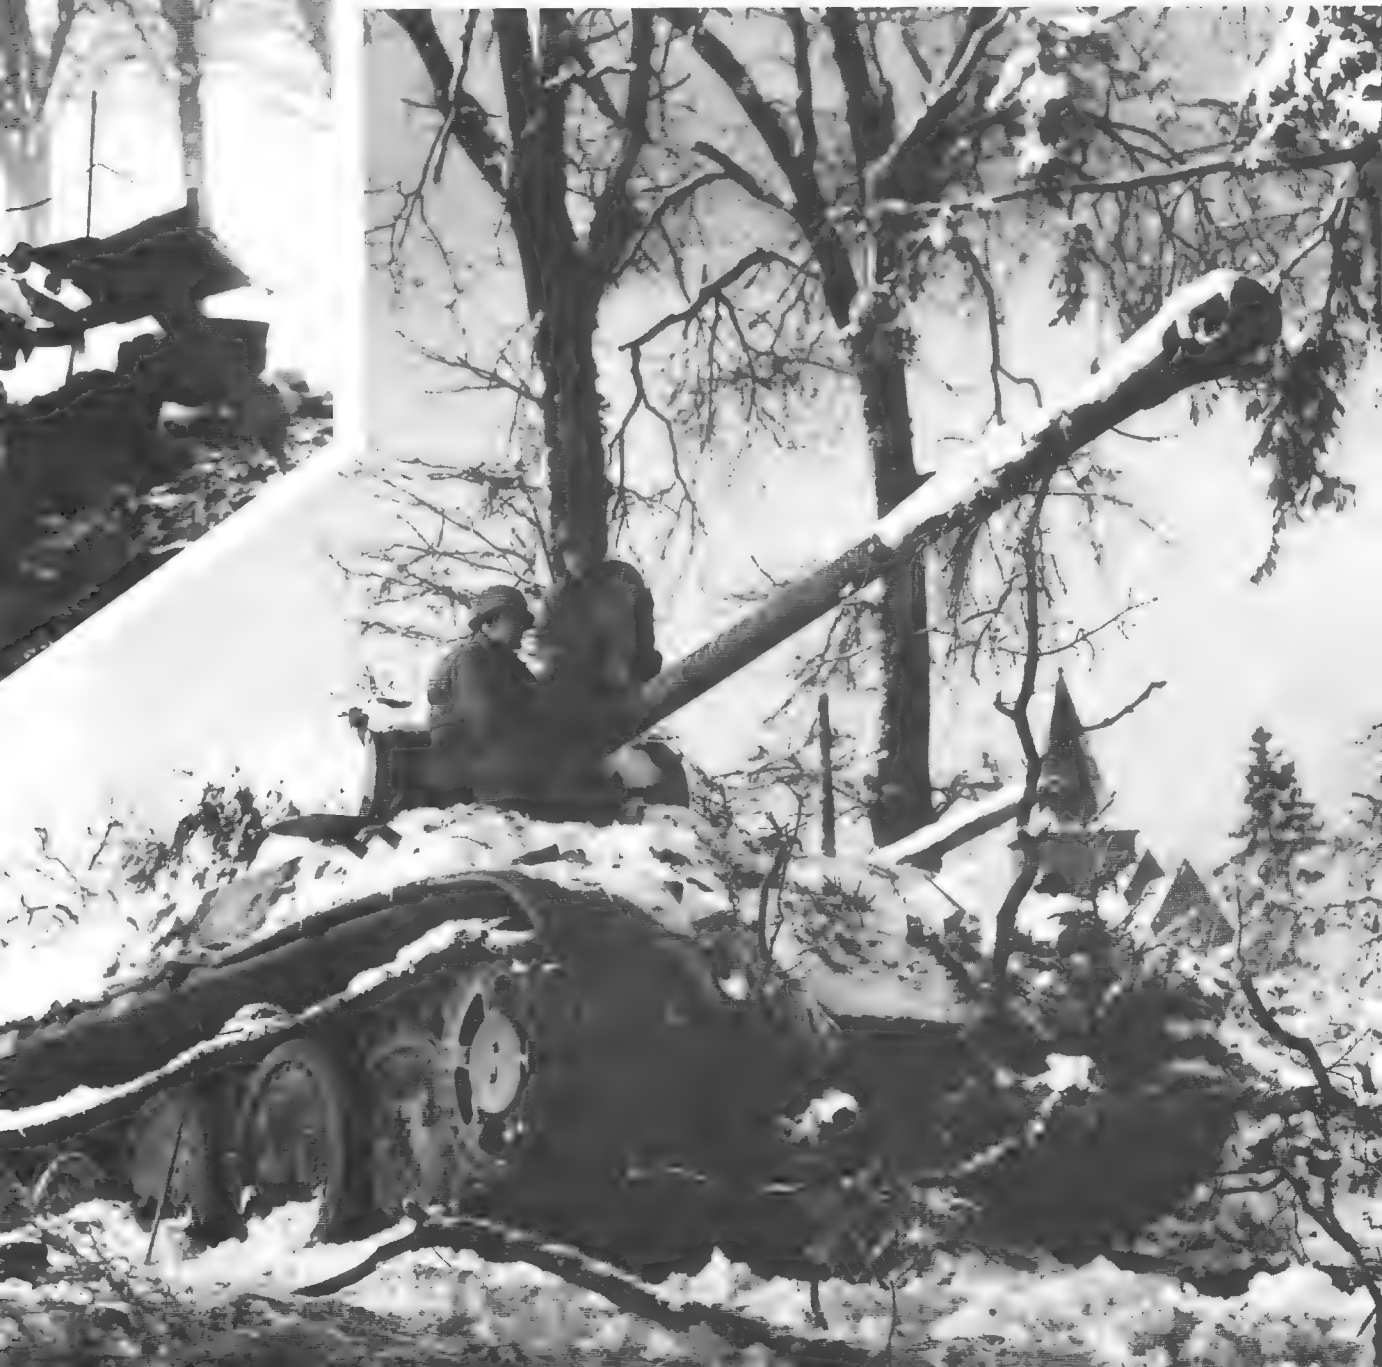
78▼

**78.** Men of the 67th Armored Regiment, 2nd Armored Division, inspect this Panther Ausf G, abandoned in the woods near Grandmenil, Belgium, after a shell had jammed in the breech of the gun, 4 January 1945. The clean lines of the redesigned hull are shown to good advantage.

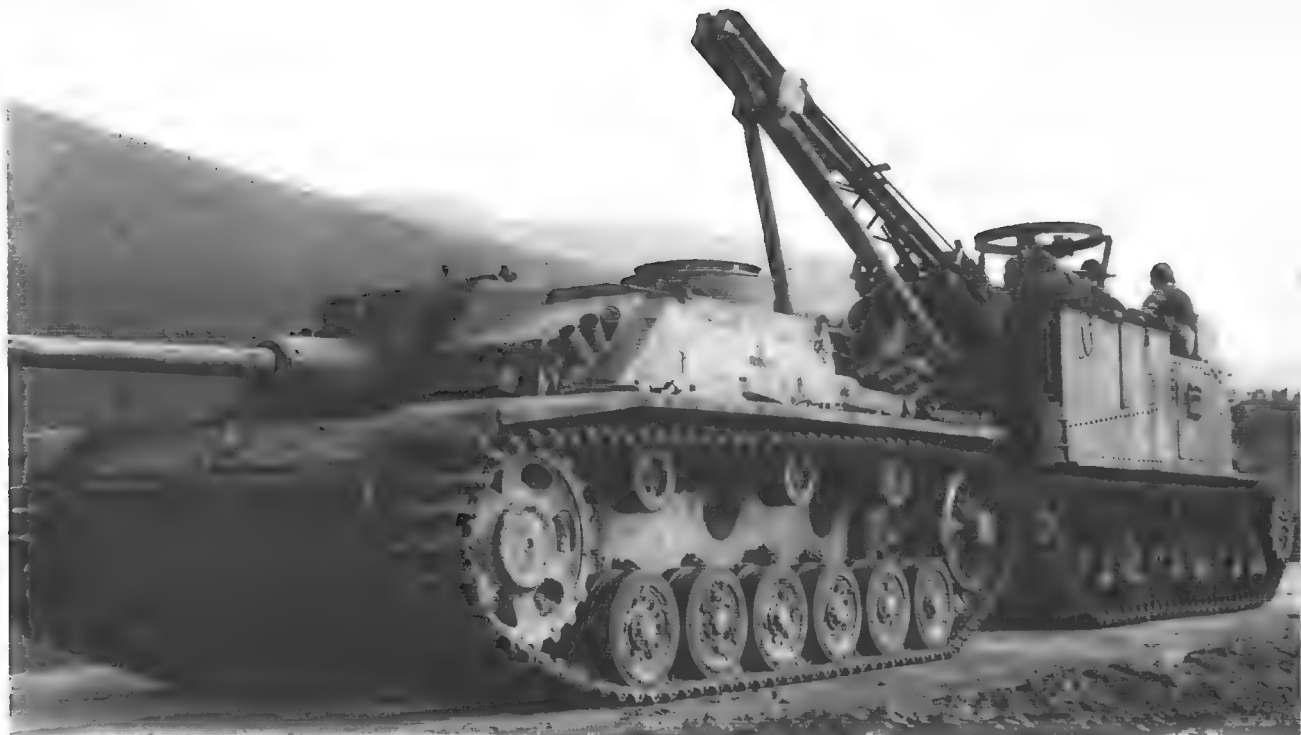
▲79

79. A StuG III Ausf G being towed down Highway 6 in the Mount Lungo area of Italy by a M31 ARV, 13 January 1944. The StuG III has 30mm armour bolted to its front hull and superstructure and is equipped with smoke projectors. The letter 'A' appears on the glacis and the superstructure side.

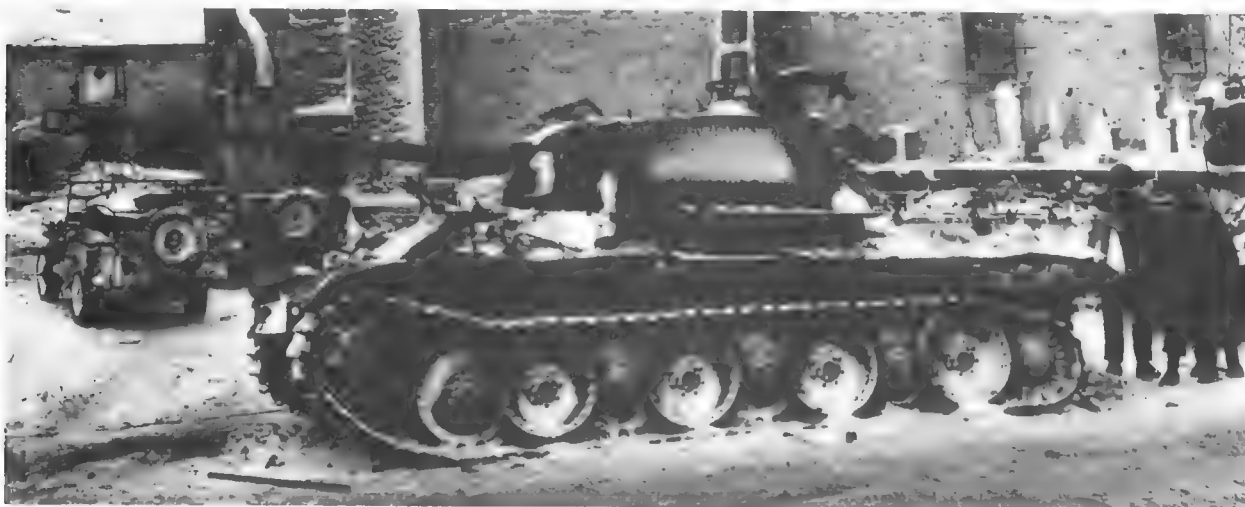
▲83 ▼84

**83.** This late-production Panther Ausf G was hit from behind by a tank destroyer moments after holing a Sherman in Sterpigny, Belgium, illustrating the hazards of tanks fighting in built-up areas. Photographed 20 January 1945, this Panther sported the 'chin' mantlet and raised engine fans, and it had the number '412' painted well back on the turret side. (US Army Photograph)

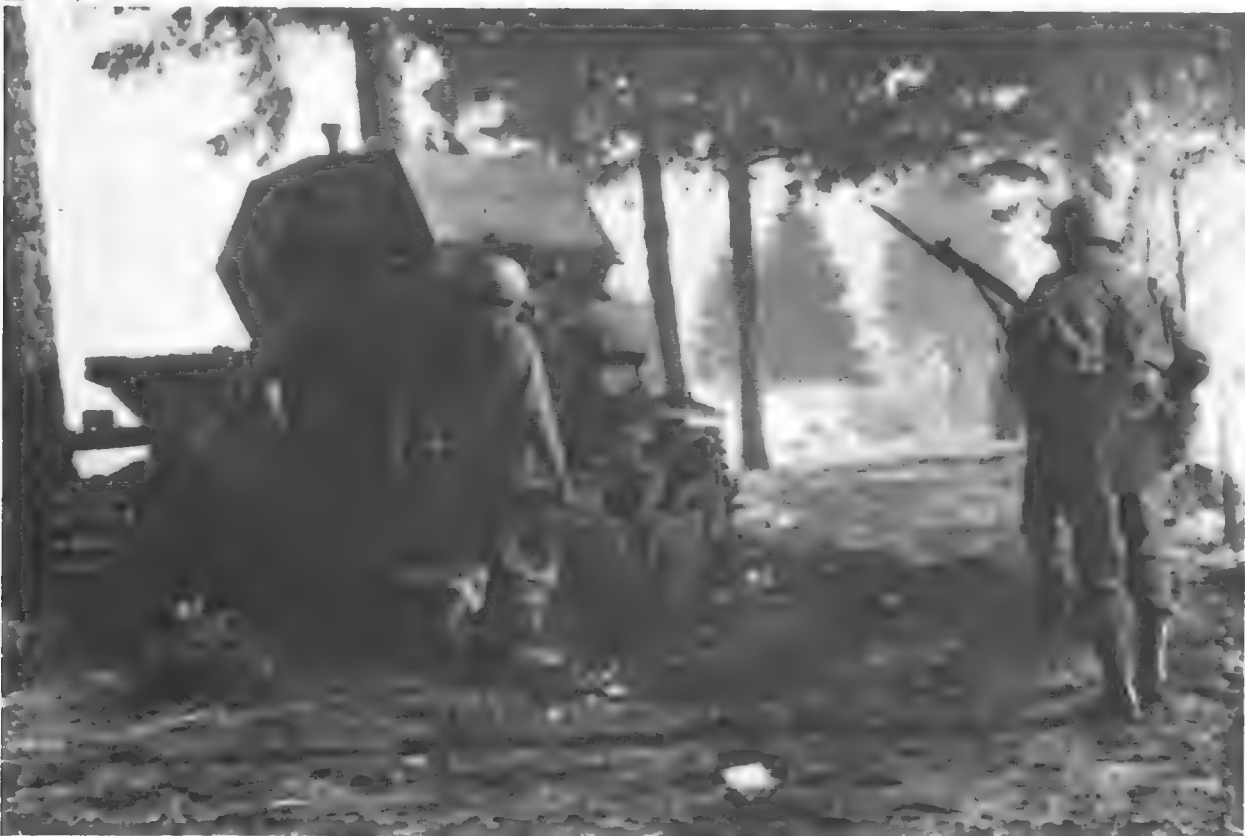
**84.** Engineers passing a knocked out FlaKpanzer IV on the road to Compogne, Belgium, 15 January 1945. All FlaKpanzers were produced on rebuilt Pz Kpfw IV chassis. This one had steel return rollers, late mufflers and welded plate over the hole for the auxiliary engine muffler. The 2cm FlaKvierling vehicles had nine-sided turrets with the rear 'wall' for the gunner. The elevating armature is visible, as are the flat stowage boxes for extra 2cm barrels over the engine air intakes.
